Factual Update

October 16, 2019

Incident Summary

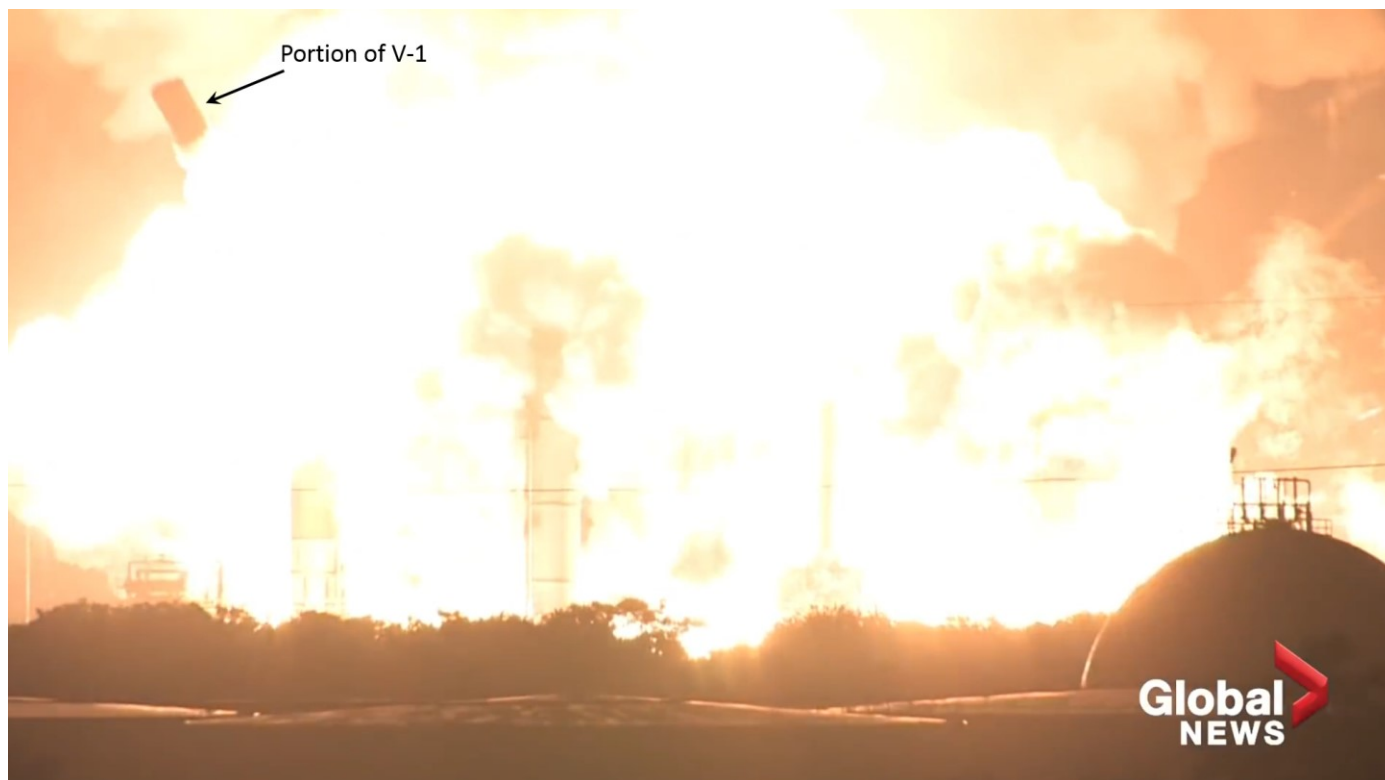
- At 4:15 am, during the ongoing fire, an explosion occurred in the alkylation unit. A second explosion in the unit then occurred at 4:19 am.
- At 4:22 am, a third, and the largest, explosion occurred when the V-1 Treater Feed Surge Drum, containing primarily butylene, isobutane, and butane, violently ruptured (Figure 4, Figure 5). A fragment of the vessel weighing approximately 38,000 pounds flew across the Schuylkill River, and two other fragments, one weighing about 23,000 pounds and the other 15,500 pounds, landed in the PES refinery (Figure 6). This appears to be a secondary event caused by the fire.

Figure 4. Video still of V-1 explosion. (Credit: Global News^a).

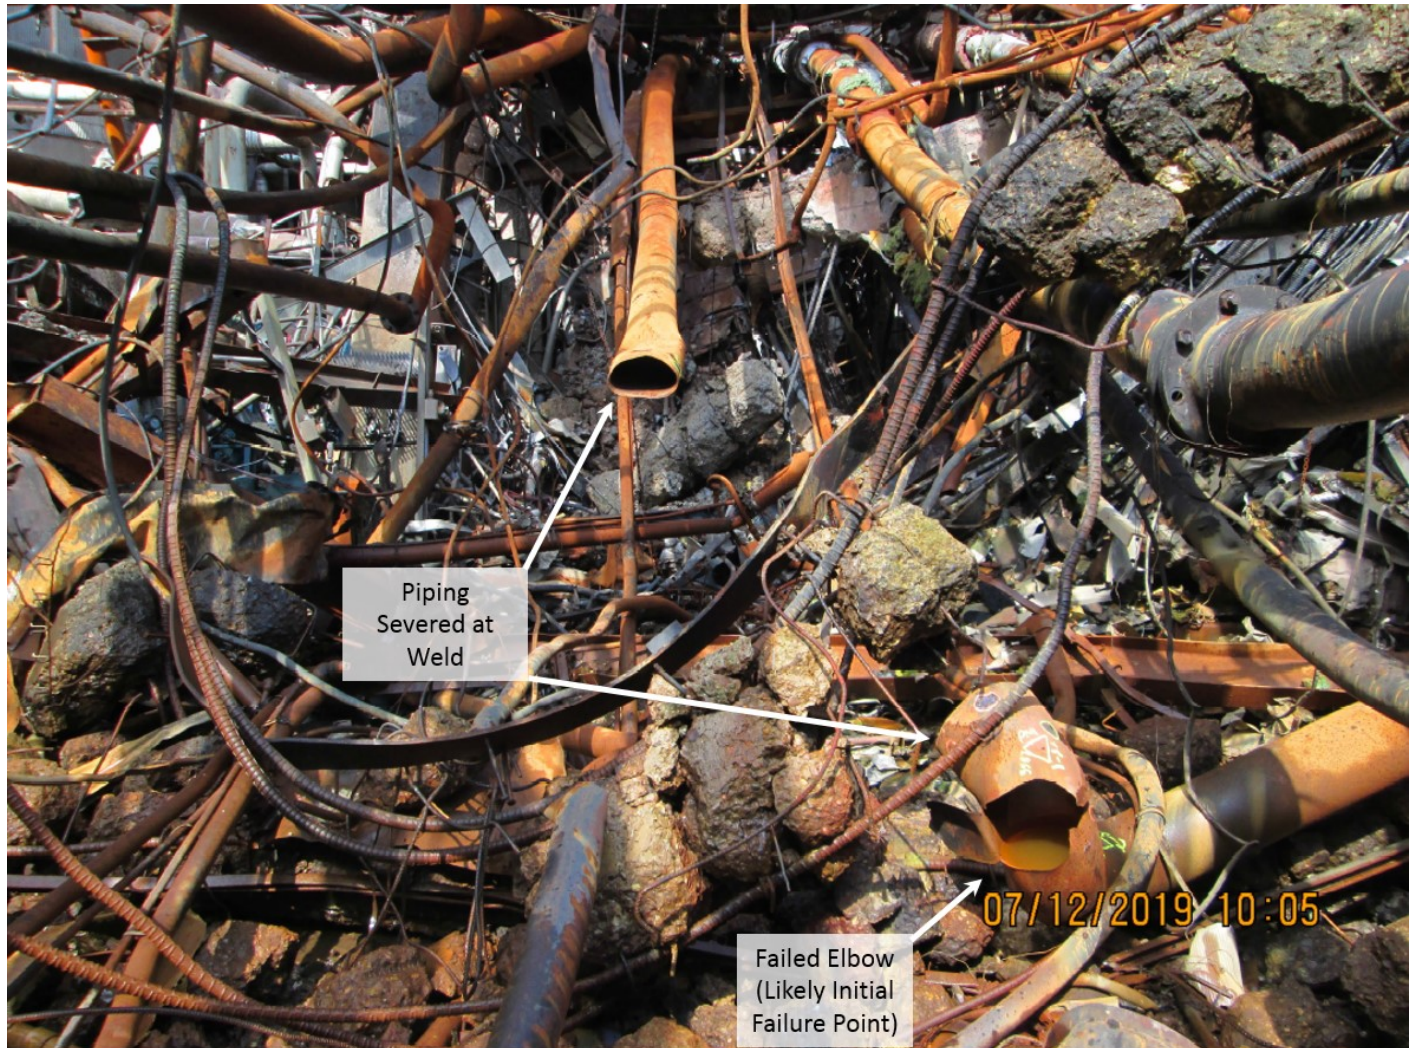
- A ruptured pipe elbow was found in the unit post-incident (Figure 7). The rupture of the elbow appears to be the initiating event causing the process fluid release. The elbow was part of the piping between V-11, the depropanizer accumulator, and T-6, the depropanizer distillation column. The elbow was on the discharge (outlet) piping from a pump (one of two pumps in this system) that was not operating at the time of the incident. At the time of the event, this piping was operating at a pressure of about 380 psig and a temperature of about 100 °F. The approximate design composition of process fluid in the piping was:

Figure 7. Photo of ruptured pipe elbow found post-incident. (Credit: PES).

- A CML was not located on the ruptured elbow, so the thickness of this elbow was not monitored. The thinnest measurement taken of the ruptured elbow post-incident was 0.012 inch.^{b,c} This value is less than 7 % of the PES default retirement thickness.

- The piping circuit containing the ruptured elbow was installed in about 1973. As of this Factual Update, this piping appears to be the original piping. Both the elbow that failed and the adjacent elbow are stamped “WPB”, indicating they were constructed to meet the ASTM A234 WPB material specifications.

- The 1965 version of ASTM A234 *Standard Specification for Factory-Made Wrought Carbon Steel and Ferritic Alloy Steel Welding Fittings*, the applicable version at the time of the pipe installation, required that Grade WPB pipe “permissible raw materials” composition meet the A106 Grade B chemical composition specifications. The 1972 ASTM A106 standard did not specify nickel (Ni) and copper (Cu) composition requirements. In 1995, ASTM A234 began specifying nickel and copper composition, as well as compositions of other elements.^a The WPB composition requirements in 1972 and 1995^b are shown below. The chemical composition of the ruptured elbow and the adjacent elbow are also shown. The nickel and copper content of the ruptured elbow exceeds the updated A234 WPB chemical composition requirements.
